OBSERVATION REPORT

Project: "The Electra" – Strata Plan LMS 1866-989
Nelson Street, Vancouver, BC

Report No. 3

ITEM: Building Envelope Field Review

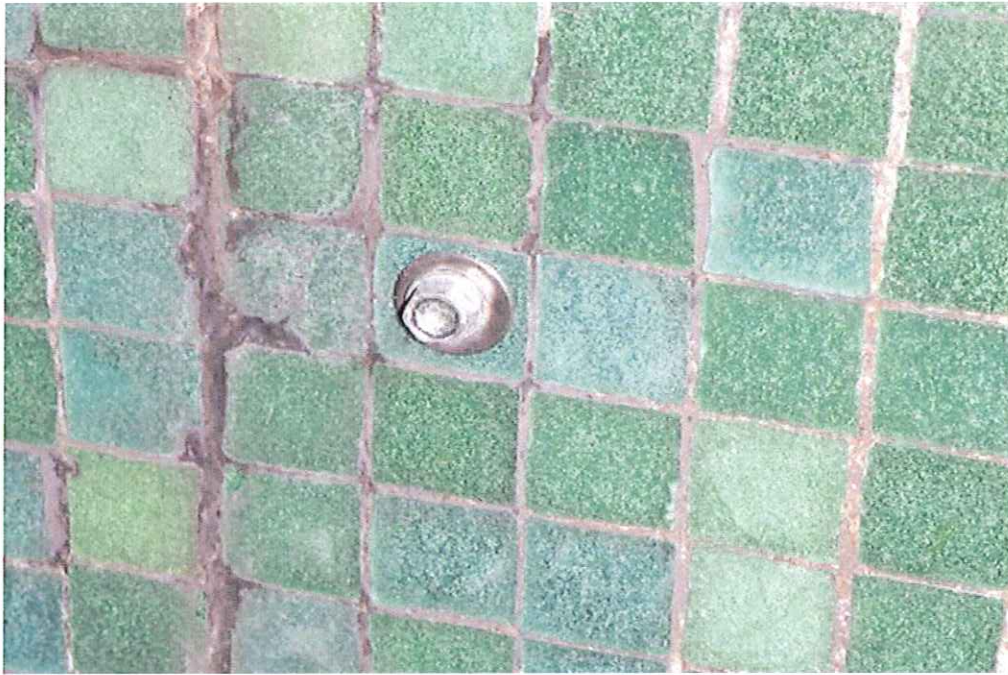
Photos No. 3.1 and 3.2

3.2	Installation of metal fasteners with ½" stainless steel washers is in good order, i.e. does not crack tiles, and is aesthetically pleasing (Photo No. 3.1 and 3.3).

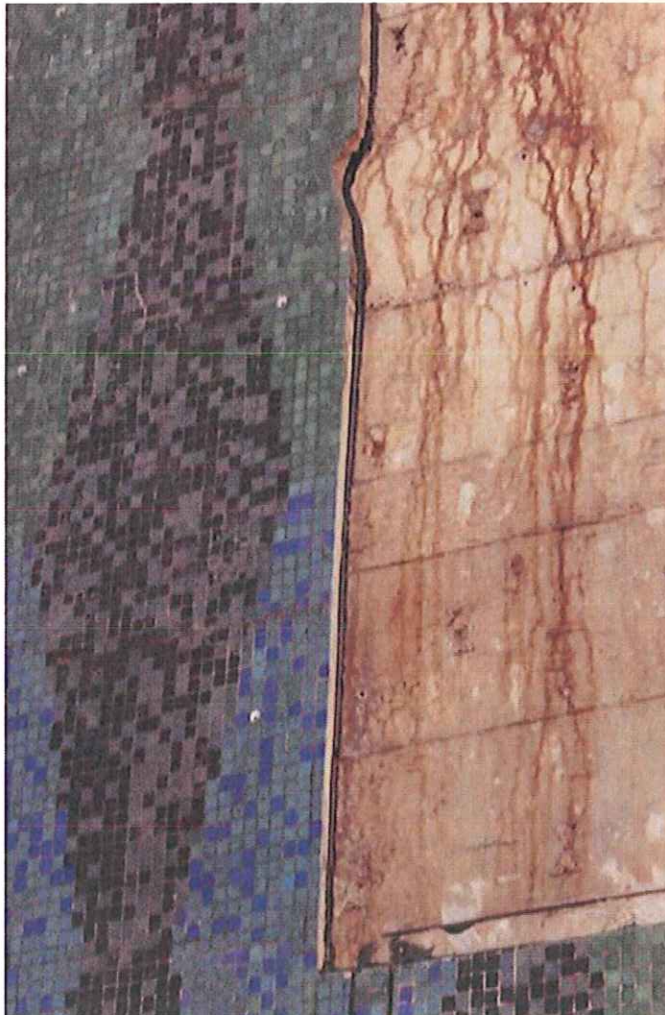
3.3	The contractor has included cleaning the building using CLR and manual techniques during installation.			
3.4	The contractor has cut out and cleaned up the section of original damage (Photo No. 3.2). It was agreed that the contractor would then cut out approximately 1½ft. of damaged area to the right of the original missing tiles.
