OBSERVATION REPORT

Project: "The Electra" - Strata Plan LMS 1866-989
Nelson Street, Vancouver, BC

File No. F07-043

ITEM: Building Envelope Field Review

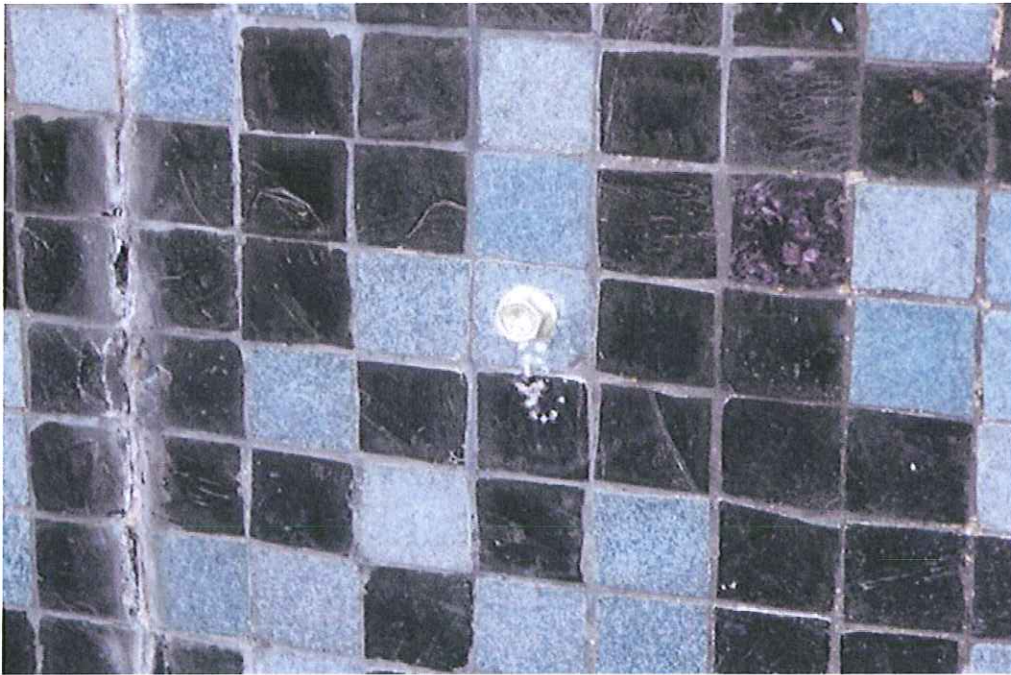
Photos No. 1.1 & 1.2

1.2	Installation of stainless steel fasteners through translucent tiles cause no problems as per photo 1, however installation of fasteners through opaque glass tiles cause tiles to crack as per photo 2. Decisions were made to install fasteners only through translucent tiles where deviation from 2'x2' grid would happen horizontally.

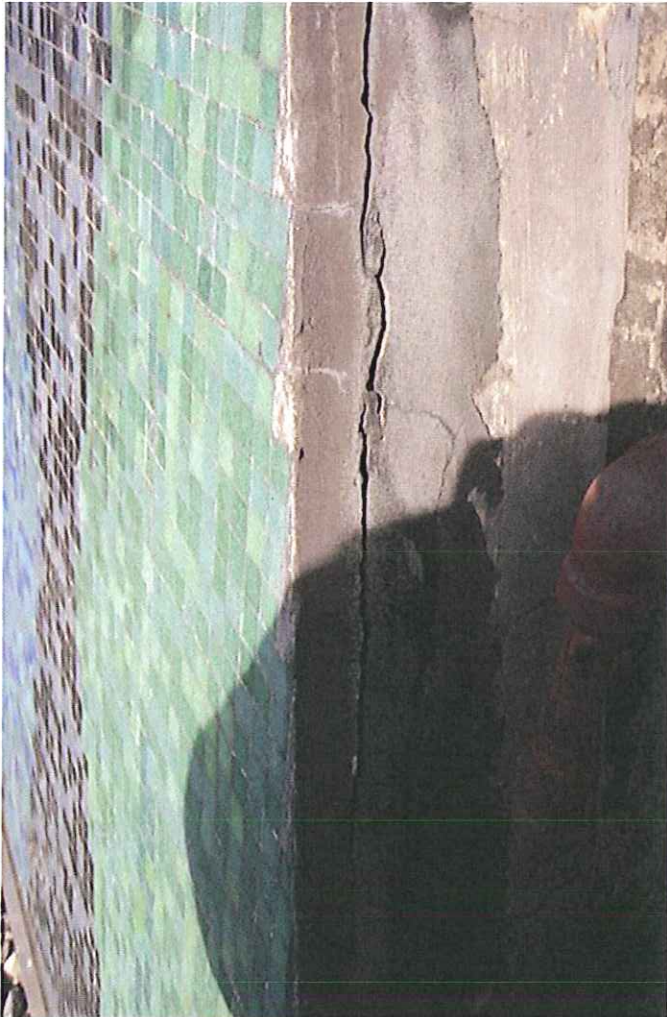
Photos No. 1.3 & 1.4

1.3	Holes pre-drilled for fasteners would be overdrilled to larger holes through the tiles and parging.			
1.4	After the installation of fasteners it is recommended that all areas where ventilation gaps were cut through original tiles and parging should be cleaned and recaulked. (Photo 3)

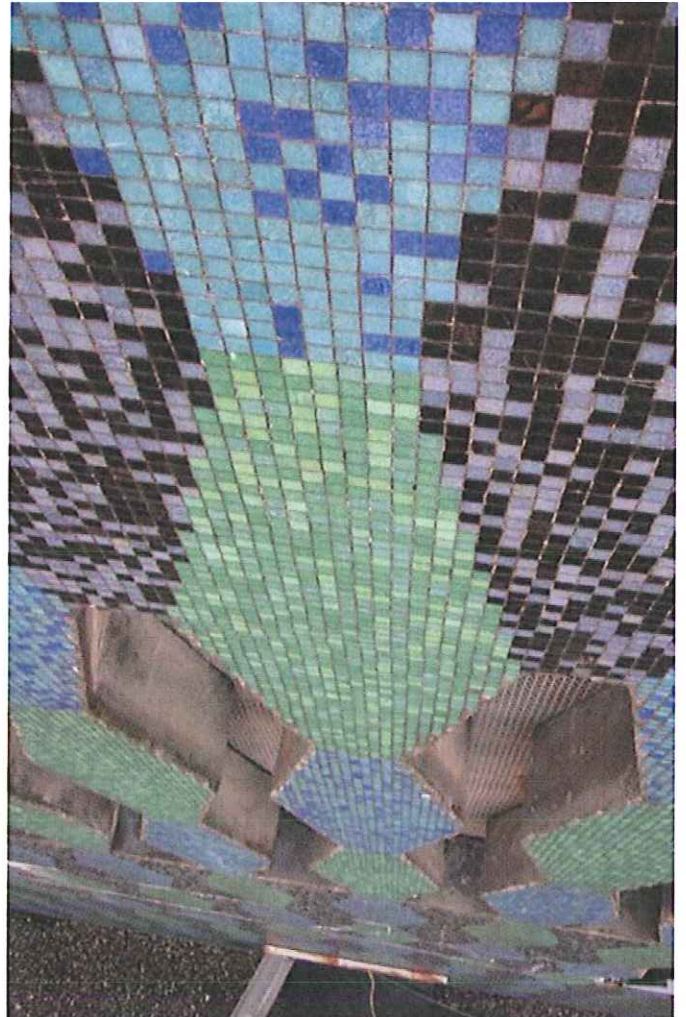
1.5	There is some concern about lack of flashing in horizontal areas of where ventilation holes have been cut through original tile and parging as shown in photo 4. It is recommended that after the fastening of the tiles has been completed all ventilation holes be properly sealed with flashing.
